Exhibit 4: Carpinteria Creek Watershed Fish Barriers

Barrier ID: BR_CA_2

Barrier ID: BR_CA_5

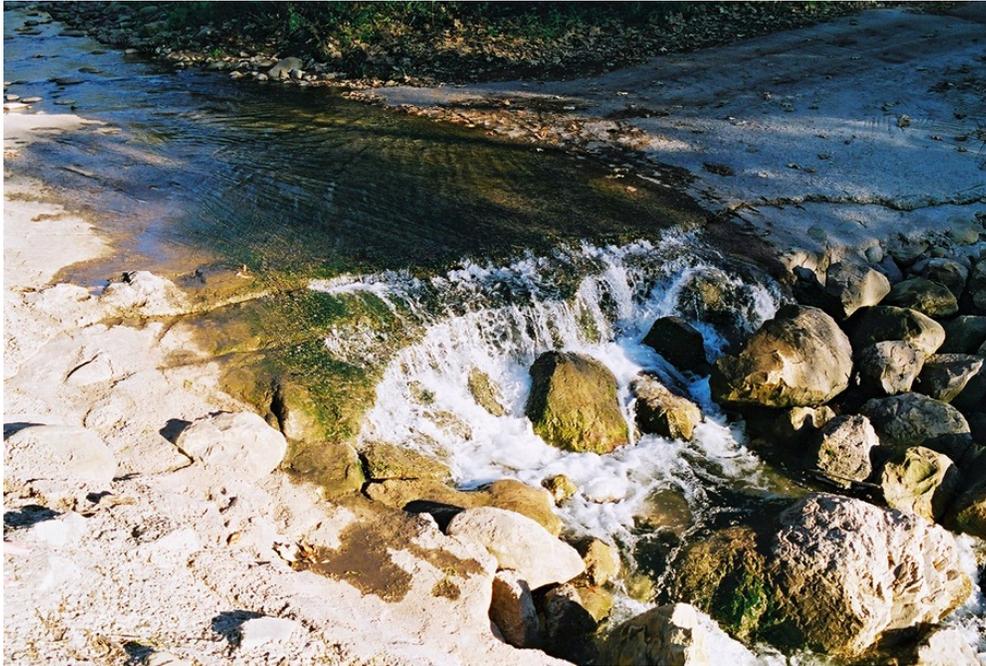
Description: This crossing consists of a concrete road that spans the entire stream channel in a mild U-shape between the bank tops. The crossing is 28 feet wide with an overall length across the creek of approximately 100 feet, depending on where measurements are taken. The overall length of the crossing from bank to bank is difficult to determine because there has been significant modification of the banks to create the gradual U-shape crossing. Downstream of the crossing, large boulders have been placed to reduce scour and undercutting of the concrete crossing. These large boulders extend downstream from the crossing 20 feet producing an irregular and moderately steep cascade. Concrete and boulder riprap extends downstream from the crossing on both banks.

Condition: The structure is in poor condition with many breaks in the concrete, exposed metal bars, significant undercutting of the downstream side of the crossing, and moderate bank erosion.

Diagnosis: The overall height of the crossing, from the bottom of the downstream pool to the downstream lip of the crossing, measured 8 feet. During moderate flows, the 2-foot deep pool at the downstream end of the boulder cascade would provide sufficient depth to provide a steelhead with a moderately difficult jump approximately half way up the boulder cascade to a small, 1-foot deep resting pool 6 feet downstream from lip of the crossing. From this resting pool, a steelhead would need to jump vertically 4 feet and horizontally 6 feet in order to land on the top of the crossing. Executing this jump from the shallow resting area would likely be impossible due to the lack of pool necessary to gain enough jumping acceleration. The shallow, sheeting flows over the crossing during low flows and fast velocities encountered during high flows make this jump, landing, and migration across this crossing extremely difficult or impossible, depending on the configuration of the downstream boulder cascade and stream flows.

Recommended Action: Due to the extremely high severity of this structure to upstream migration and location downstream of virtually all productive spawning and rearing habitat in the watershed, this structure must be removed or modified to ensure effective upstream passage of steelhead. The Carpinteria Creek Committee and Department of Fish and Game are currently working on addressing improved steelhead passage at this site. Removing this structure and replacing it with a bridge that does not impact the channel is recommended and would provide the most effective, long-term solution to the fish passage situation and possibly for the landowner. The relatively narrow stream channel provides an adequate situation for a bridge at, or near, this site. Because of the significant amount of sediment trapped behind this crossing and the change in streambed elevation downstream, additional studies are needed to determine what possible impacts would be associated with removing this structure. Carl Stucky, who is a contact with the owner of the crossing, reported that a bridge would need to be able to carry 40,000 pounds of weight and ideally a gate restricting access from the public at the Highway 192 entrance would accompany a new crossing.

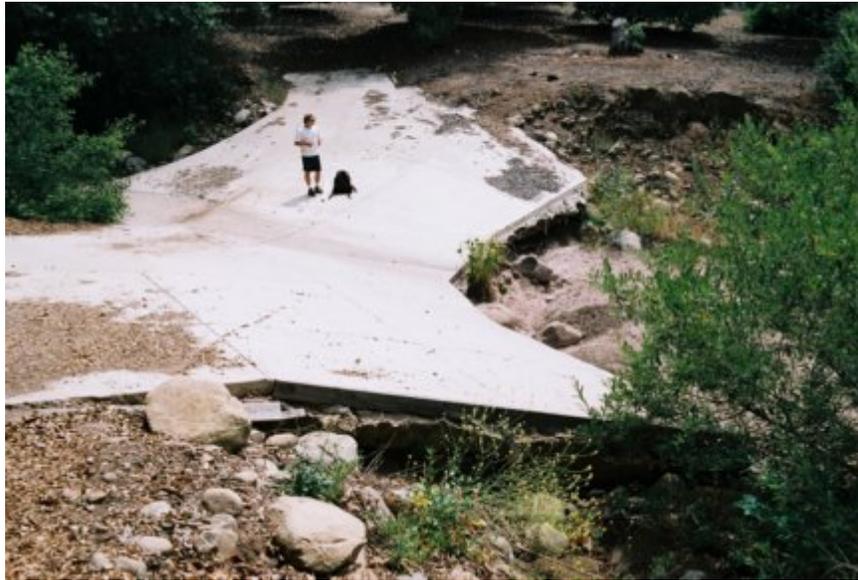
Description: This concrete crossing spans 76 feet across the stream channel and into loose silt, sand, and cobble-dominated banks. A 2-foot diameter metal pipe extends from under the structure. The crossing has a shallow concave in order to concentrate stream flows across the center of the smooth concrete surface. The centerline of this concave has three distinct slope changes along the 33 feet from the downstream lip to the upstream lip. Starting from the downstream edge, the first 9 feet had the steepest slope measured at 15.7%. The next 15 feet had a slope measured at 6.1%. The most upstream 9 feet, where vehicles would cross the structure, has the mildest slope of 3.7%. The surface of the structure rises 2 feet 8 inches over 33 feet for an average slope of 8.1%. 100 feet downstream from the crossing, the slope of the natural streambed was measured at 2.6%. The concrete measured between 2 and 2.5 feet thick from the exposed footing to the surface lip on the downstream side of the crossing. Downstream scour has produced a 4-foot vertical drop from the downstream edge of the structure to the deepest part of the streambed where a jump pool for steelhead would form during migration flows.

Condition: The concrete is in fairly good condition but the structure has been severely undercut and side cut by stream flows that have caused major downstream scour under the entire structure and on both stream banks. A large hole on the upstream side of the crossing has undercut the middle of the structure and washed away streambed material that the concrete crossing was original poured onto producing a 15-foot wide by 17-foot long void under the crossing that is over 2-feet deep. This crossing is on the verge of complete failure and presents a hazard both to vehicular passage over the crossing and to private property during flood flows.

Diagnosis: The undersized metal pipe under the crossing is non-functional with the intake buried under the sediment backed up behind the structure. No fish passage could occur through this pipe. At the time of the survey there was no visible route under the crossing. Assessment of watermarks, substrate scour, and the downstream tail-water control indicates that a pool of at least 2 feet deep will develop downstream of the crossing during migration flows. During these conditions, a moderately difficult jump of 2 feet would allow steelhead to jump onto the downstream portion of the crossing. The smooth concrete and slope of over 15% would have shallow, high velocity flows making upstream migration extremely difficult or impassable for adult steelhead. In addition, the flows passing under the crossing into the jump pool would interfere with hydraulic conditions needed for jumping onto the structure.

Recommended Action: Work with landowner to determine if this structure is necessary or if alternative crossings in the area could provide access across the stream. If the crossing is not necessary or access can be obtained elsewhere, it is recommended that the structure be removed and the banks stabilized and planted with a small buffer of native riparian vegetation. The extent of sediment trapped upstream of the structure will need to be assessed prior to removal. If access at this site is necessary, a bridge with no encroachment in the stream channel is recommended.
