August 14, 2006
Project No. P022-06

SUBJECT: GEOLOGIC RECONNAISSANCE LETTER REPORT
Formerly Proposed Building Site on APN 518-112-02
Freshwater Lagoon Road
Orick, California

Geologic Reconnaissance APN 518-112-02
Freshwater Lagoon Road, Orick, California

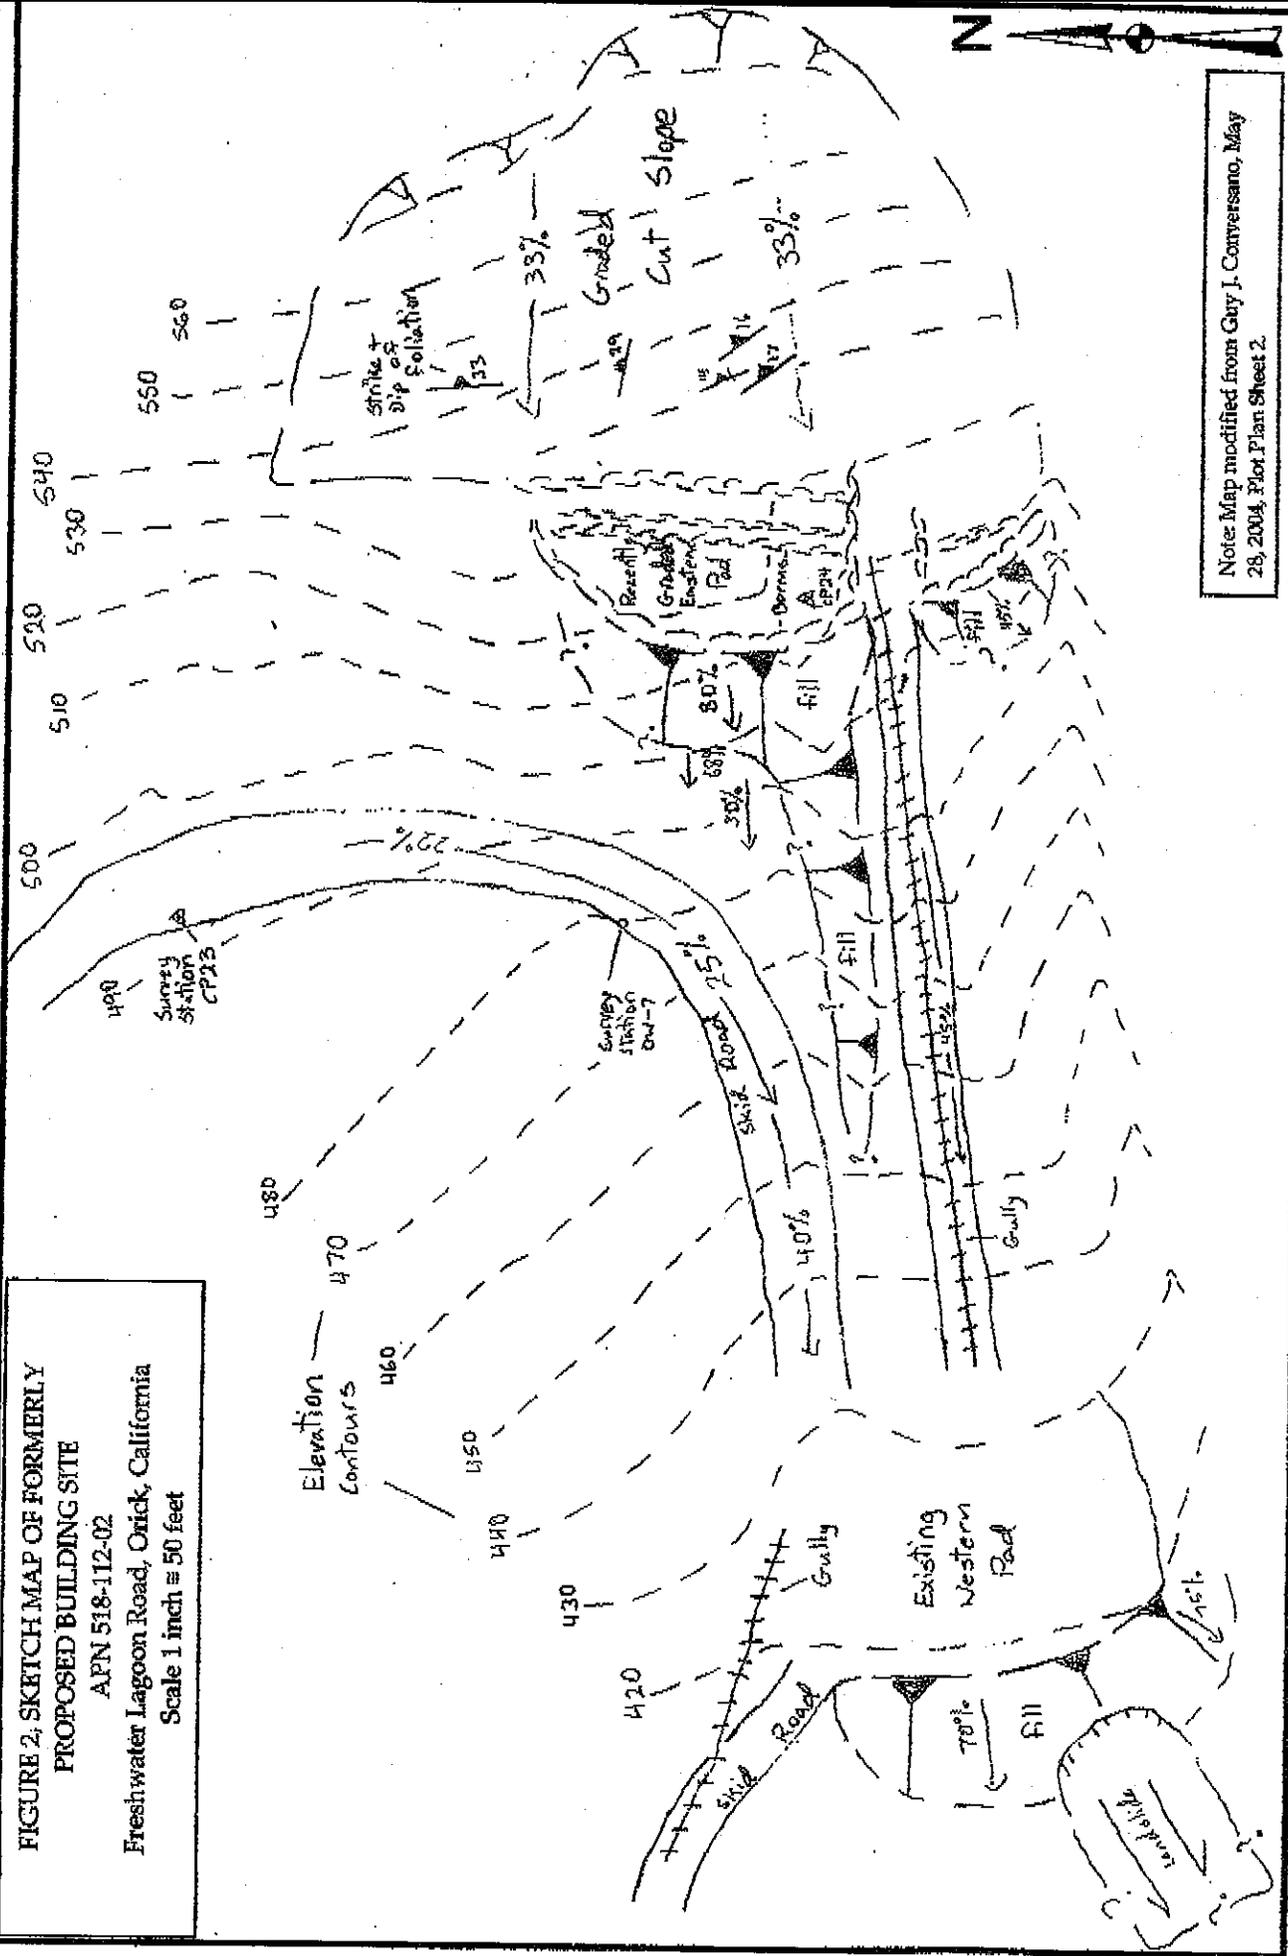
FIGURE 2. SKETCH MAP OF FORMERLY
PROPOSED BUILDING SITE
APN 518-112-02
Freshwater Lagoon Road, Orick, California
Scale 1 inch = 50 feet

In the eastern area of the formerly proposed building site we observed a large cut slope that extends uphill about 126 feet and is inclined at about 33 degrees, as shown on Figure 2. During our reconnaissance we observed schist exposed in the cut slope. The foliation of the schist dips gently into the slope, as shown on Figure 2. The slope is partially vegetated with grass and young alders. Also no indications of concentrated runoff, such as rilling, were observed on the rock cut-slope.

Adjacent to the west of the cut slope is the formerly proposed building site, which is characterized a recently graded relatively flat-lying pad (Figure 2). At present the pad is overgrown with a dense stand of alders up to about 12 feet tall. A road has been graded and is located adjacent to the rock cut-slope. Schist was observed cropping out in the road surface. Along the western margin of the road and the western margin of the building pad area we observed several berms, which were oriented roughly parallel to the graded road and up to 2-feet high. The berms appeared to be composed of gravel-sized schist rock fragments, likely from grading of the road and adjacent hillside. It appears that the berms were intended to act as sediment traps for debris that might be eroded from the adjacent cut slope. We observed some sediment, up to about 2 inches deep, collecting behind the berms. A road cut, about 10 feet south of survey station CP24, revealed up to 5 feet of fill in the western margin of the graded pad. The fill consists largely of broken gravel- to cobble-sized, schist rock fragments in a fine-sandy to silty matrix. The fill slopes associated with this pad are steeply inclined at about 80 percent towards the west and are up to about 25 feet in length, as shown on Figure 2. A dense stand of alders covers the fill slope.

Slope stability issues related to the recently graded pad adjacent to the large cut slope in the eastern are of the site are centered on the fill slopes along the western margin of the pad (See Figure 2). These fill slopes are currently inclined at inclinations from 45 to 80 percent and are densely vegetated. The slopes inclined at 45 percent are at an inclination less than the accepted UBC standard of 2 to 1 (H:V) and therefore the potential for slope instability on those slopes is low. The steeper slopes, inclined at about 80 percent, are about 25 feet in length. To the west of these steeper fill slopes, slope inclinations become gentler as they approach an existing skid road. The skid road, in this area, is inclined at about 25 percent and is densely vegetated. At present these steeper fill slopes appear to be performing adequately as no indication of instability such as ground cracks were observed. Based on our observations it is our judgment that the fill slopes associated with the western margin of the recently graded pad are functioning adequately. However, if materials in the fill prism were to fail it would be small in volume and debris would likely end up on the gently-inclined and densely-vegetated skid-road surface roughly 40 feet downslope.

Slope stability issues related to the existing pad located in the western area of the site are centered on the fill slopes along the western margin of that pad (See Figure 2). These fill slopes are currently inclined at inclinations around 70 percent and are densely vegetated with alders. The majority of the fill slope appears to be functioning adequately. However, as noted earlier we observed a relatively small landslide in the southwestern portion of the fill. This landslide is densely vegetated with alders up to about 13 feet high as well as shrubs and grass suggesting that the slide probably has not moved in recent years. The vegetation provides a significant amount of root strength, interception, and evapotranspiration which help to reduce the potential for renewed movement. The topography downslope of the landslide is characterized by densely-vegetated, gently-inclined slopes. If this landslide were to reactivate debris would likely come to rest on the gently-inclined slopes below.

1. Upon sale of this property the potential buyers shall be notified of this report.
2. Upon further development of this site, the recently graded cut and fill slopes addressed in this report shall be addressed by the project engineer and should be brought up to UBC standards. In particular the fill slopes tested by SHN are below compaction standards and should be addressed by the project engineer as pertinent to future development of the site.
3. Upon further development of this site, the two erosion gullies observed at the site shall be addressed by the project geologist/engineer such that they do not adversely impact any proposed building sites.
4. Upon further development of this site, the small landslide nested in the existing pad shall be addressed by the project geologist so that the slide does not adversely impact any proposed building sites.
