Exhibit 4: Carpinteria Creek Watershed Fish Barriers

Barrier ID: BR_CA_2

Barrier ID: BR_CA_5

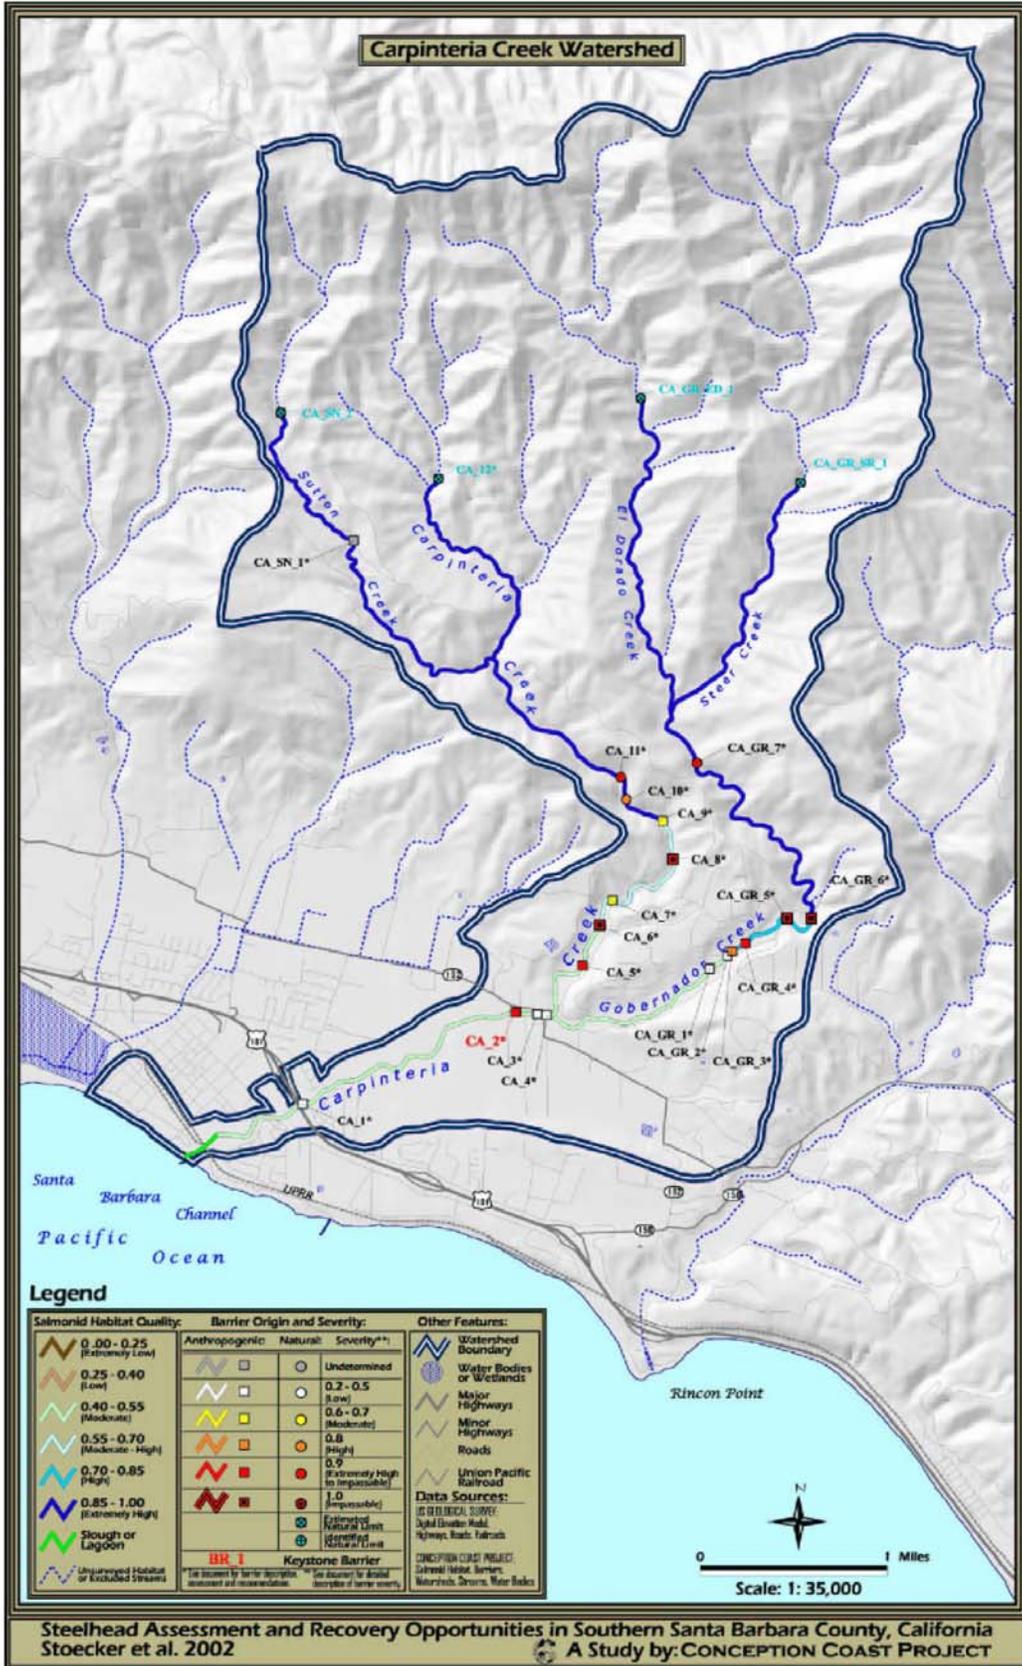
Description: This crossing consists of a concrete road that spans the entire stream channel in a mild U-shape between the bank tops. The crossing is 28 feet wide with an overall length across the creek of approximately 100 feet, depending on where measurements are taken. The overall length of the crossing from bank to bank is difficult to determine because there has been significant modification of the banks to create the gradual U-shape crossing. Downstream of the crossing, large boulders have been placed to reduce scour and undercutting of the concrete crossing. These large boulders extend downstream from the crossing 20 feet producing an irregular and moderately steep cascade. Concrete and boulder riprap extends downstream from the crossing on both banks.

Condition: The structure is in poor condition with many breaks in the concrete, exposed metal bars, significant undercutting of the downstream side of the crossing, and moderate bank erosion.

Diagnosis: The overall height of the crossing, from the bottom of the downstream pool to the downstream lip of the crossing, measured 8 feet. During moderate flows, the 2-foot deep pool at the downstream end of the boulder cascade would provide sufficient depth to provide a steelhead with a moderately difficult jump approximately half way up the boulder cascade to a small, 1-foot deep resting pool 6 feet downstream from lip of the crossing. From this resting pool, a steelhead would need to jump vertically 4 feet and horizontally 6 feet in order to land on the top of the crossing. Executing this jump from the shallow resting area would likely be impossible due to the lack of pool necessary to gain enough jumping acceleration. The shallow, sheeting flows over the crossing during low flows and fast velocities encountered during high flows make this jump, landing, and migration across this crossing extremely difficult or impossible, depending on the configuration of the downstream boulder cascade and stream flows.

Recommended Action: Due to the extremely high severity of this structure to upstream migration and location downstream of virtually all productive spawning and rearing habitat in the watershed, this structure must be removed or modified to ensure effective upstream passage of steelhead. The Carpinteria Creek Committee and Department of Fish and Game are currently working on addressing improved steelhead passage at this site. Removing this structure and replacing it with a bridge that does not impact the channel is recommended and would provide the most effective, long-term solution to the fish passage situation and possibly for the landowner. The relatively narrow stream channel provides an adequate situation for a bridge at, or near, this site. Because of the significant amount of sediment trapped behind this crossing and the change in streambed elevation downstream, additional studies are needed to determine what possible impacts would be associated with removing this structure. Carl Stucky, who is a contact with the owner of the crossing, reported that a bridge would need to be able to carry 40,000 pounds of weight and ideally a gate restricting access from the public at the Highway 192 entrance would accompany a new crossing.
